Inspector's Daily Report

IDR Sheet	1	of	1	Sheets	Final Record Book	Page
Contract	=		D	ay		Date
C-7852				Tuesday		June 21, 2011

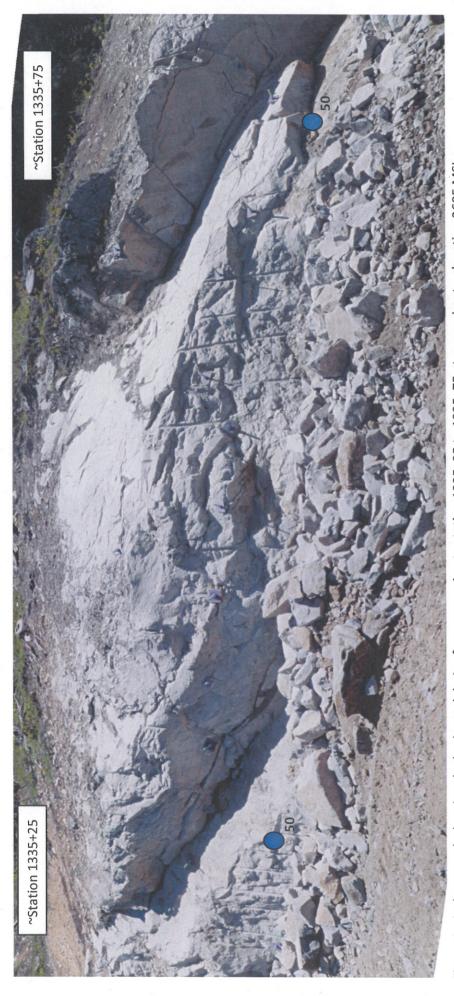
Figure 1. A photograph showing the horizontal drains from approximate station 1335+25 to 1335+75 at approximate elevation 2605 MSL.

50 Horizontal Drains (Minimum Length in Feet)

I drove to the Hyak office and met with Brad around 10:00 am. We discussed the project and drove to the east side of the project around 11:00 am. Brad and I were able to lay out two 50 foot horizontal drains between stations 1335+25 and 1335+75 (~2605 MSL) and three 55 foot Type H rock dowels between stations 1332+55 to 1332+80 (Figures 1 and 2). About four more 55 foot Type H rock dowels need to be located between 1332+00 and 1332+55; however, there remains oversize blocks on the wall face and the bench needs to be excavated a few more feet towards the west end of the bench before we are able to place the dowels.

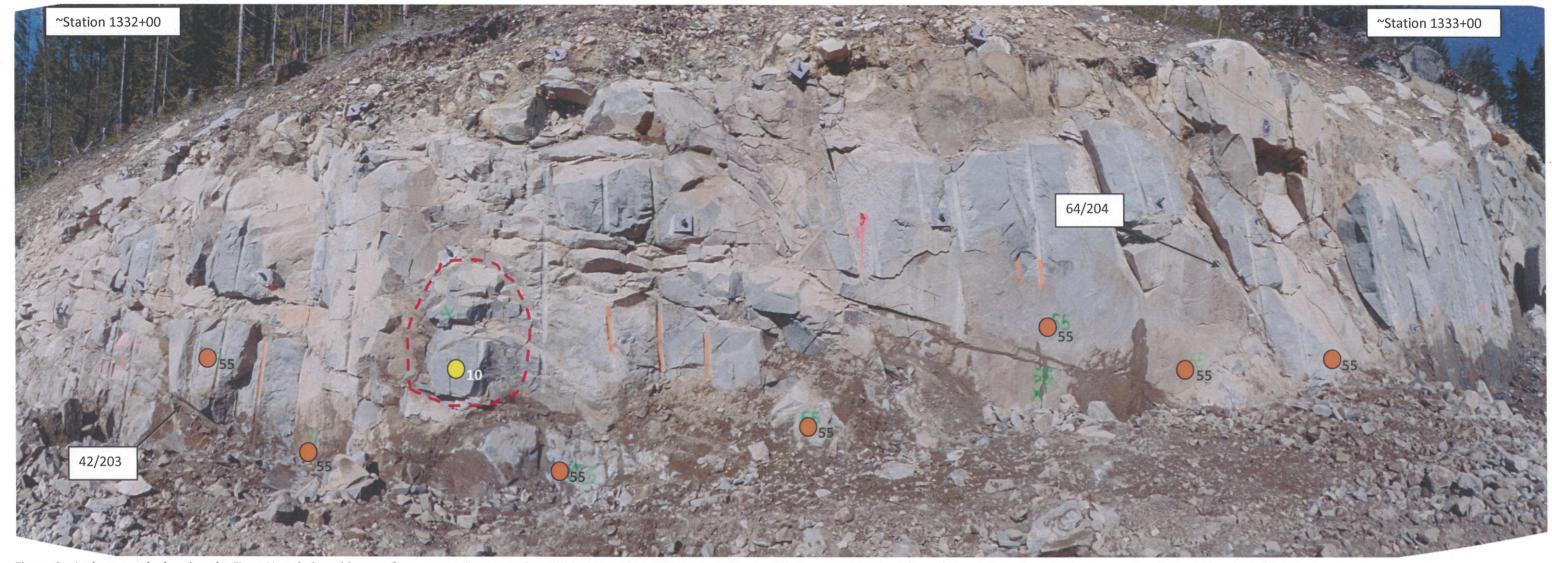
Figure 2. A photograph showing the Type H rock dowel lay out from approximate station 1332+00 to 1333+00 at approximate elevation 2624 MSL. A few of the pattern dowels were moved up to include nearby structure.

Type H Rock Dowels (Minimum Length in Feet)

Possible spot dowel location (Minimum Length in Feet)

Approximate scaling and dressing limits.

Brad and I drove to the east side of the project around 3:30 pm and the contractor was still mucking material from approximate station 1332+00 to 1336+00. By 4:00 pm, the majority of the face was cleared for us to lay out the remaining bolts from approximate station 1332+00 to 1333+00. In total, seven 55 foot Type H rock dowels were located from 1332+00 to 1333+00 at approximate elevation 2624 MSL. Two of the pattern dowels were moved to include nearby structure instead of installing spot dowels. Brad and I also located an area that required additional scaling and dressing from the contractor (Figure 1). If the rockmass is not able to be scaled, then a 10 foot spot dowel should be placed in the lower half of the rockmass (Figure 1).
